Article | Received 14 January 2025; Accepted 25 April 2025; Published 20 June 2025
<https://doi.org/10.55092/sc20250014>

Multi-dimensional data interpretation for defective filter identification

Keywords: water treatment plant; filter diagnosis; point cloud; time series analysis

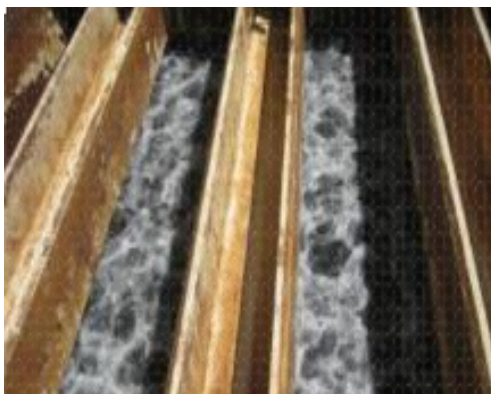
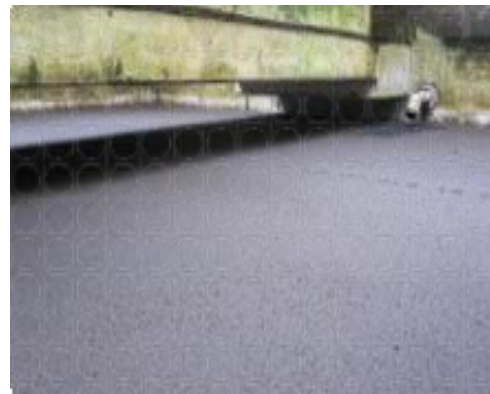
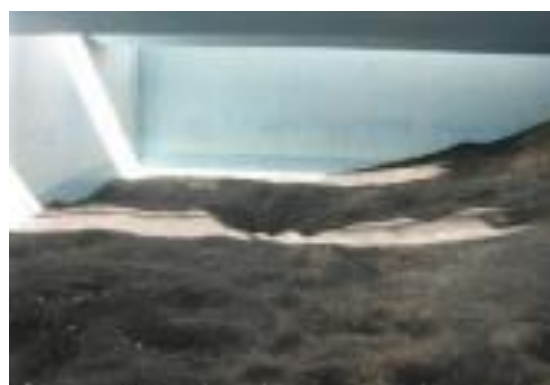
Proper backwashing is crucial for the effective maintenance of a filter. As depicted in Figures 2(a) and 2(b), uniform water flow results in an even medium surface after draining. In contrast, improper backwashing, as shown in Figures 2(c) and 2(d), leads to uneven surfaces after draining despite uniform water flow. Improper backwashing can cause media loss, media mixing, and the formation of mud balls, cracks, and craters, all of which contribute to inadequate filtration and increased effluent turbidity.

(a) Normal backwash

(b) Even surface after draining

(c) Hot spot backwash

(d) Uneven surface after draining

Figure 2. Backwash and medium surface [7] (Reprinted with permission. Copyright (2014), Laurel Passantino and Jacqueline Rhoades).

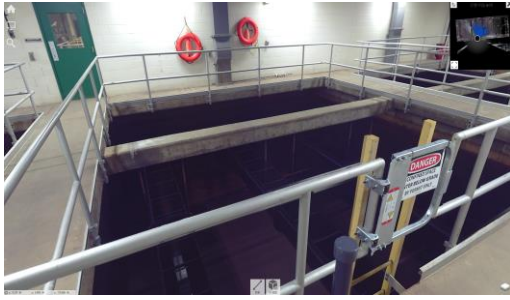
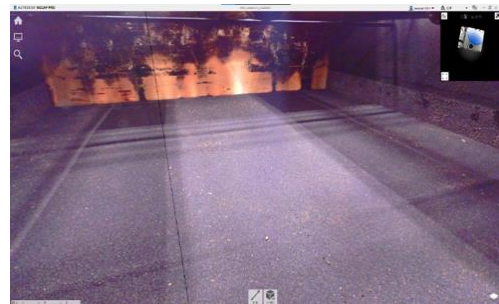
As depicted in Figures 5(a) and 5(b), the water filter is a rectangular tank installed underground. To scan the surface of the water filter media, an upside-down laser scanner is installed, enabling the collection of 3D point cloud data representing the geometric information of the filter surface, as shown in Figures 5(c) and 5(d). Before backwashing, the water filter medium appears brown and dirty (Figure 6(a)). The subsequent steps—backwash air scouring, filter boiling, and filter-to-waste—are

(a) Top of the water filter

(b) Upside-down installation of the laser scanner

(c) 3D points cloud data of the water filter

(d) The surface of the water filter

Figure 5. Water filter media surface point cloud dataset collection.

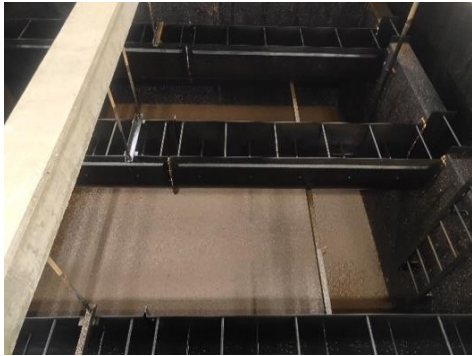
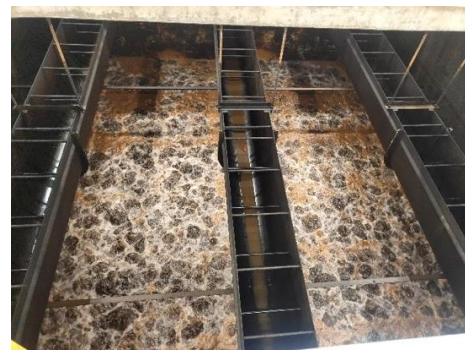
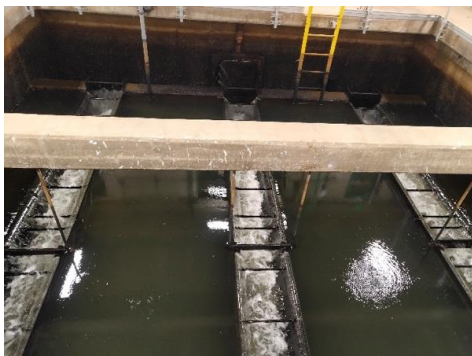
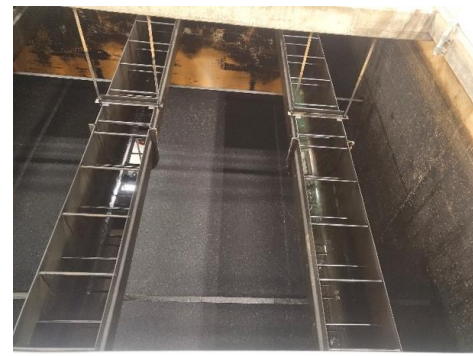
carried out in sequence (Figures 6(b) and 6(c)). Thereafter, the water filter medium is restored to a gray, clean state (Figure 6(d)).

(a) The surface of the water filter medium before backwash

(b) Backwash air wash and filter boils

(c) Filter-to-waste backwash

(d) The surface of the water filter medium after backwash

Figure 6. The processes of the water filter backwash.

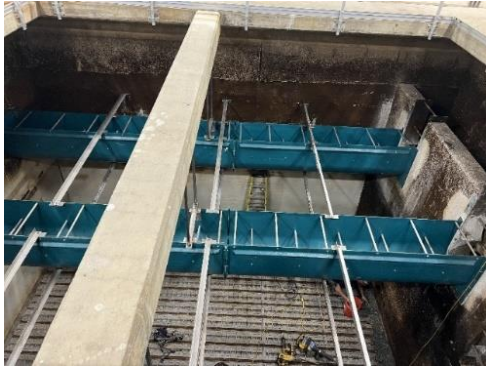
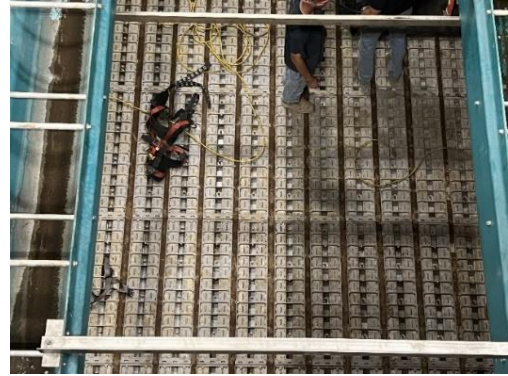
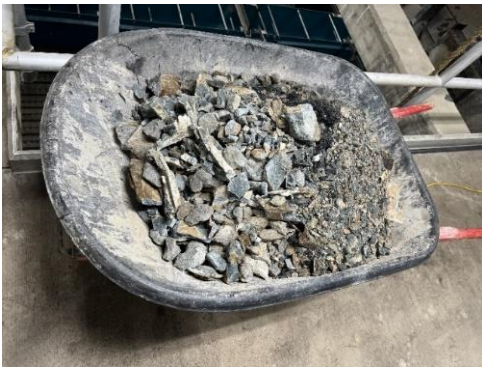
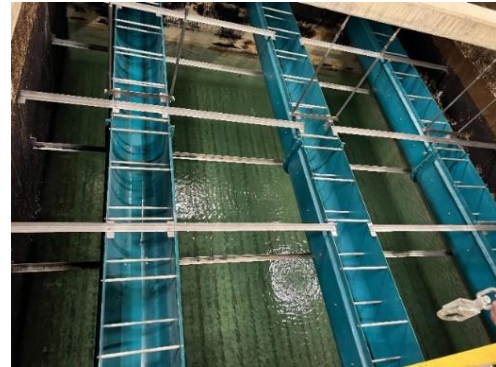
After nine years, the six-filter medium will be replaced with a new medium. Basically, workers would dig the medium and expose the underdrains to inspect whether the underdrains are blocked with sand or particles, as shown in Figure 7(a). At the same time, workers would clean the left gravel support bed materials in the underdrains. Figure 7(b) shows the materials from the drilled gravel support bed. After inspecting the underdrains, the water treatment plant operators would wash the underdrains without any medium to clean the underdrain systems, as shown in Figure 7(c).

(a) Underdrains inspection

(b) The gravel supports bed materials

(c) Backwash of underdrain

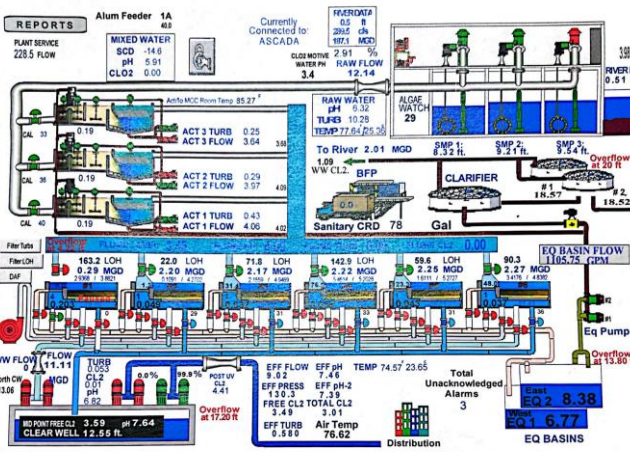
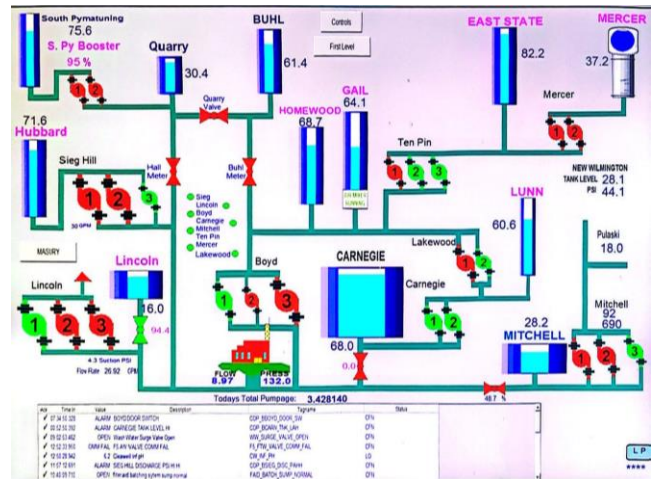
We obtain the sensor data from the SCADA system of the water treatment plant as shown in Figure 9, including (1) flow rate, (2) effluent turbidity, (3) loss of flow; (2) effluent turbidity, (3) loss of head, (4) backwash rates, (5) filter levels, (6) flume levels (filter influent flume level) and (7) filter status (13 assigned numbers for each status, as shown in Table 2).

(a) The SCADA layout of the water treatment plant includes six filters

(b) The connections between the pumps and valves

(c) The detailed control screen of the water filter

(d) Backwash setpoints and timers

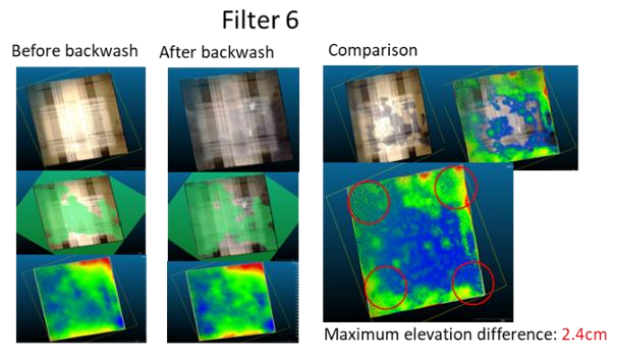
During operation and backwashing, the filter media within the water filter can be dislodged by water flow, reducing media depth. Measuring the media’s depth serves as an indicator of the filter media’s functional status. Utilizing point cloud data of the water filter, the ground is set as the reference plane to measure the distance between the surface of the filter medium and the ground, as illustrated in Figure 11. Among the six filters analyzed, Filter 2 exhibits the lowest average medium elevation compared to the other five filters as shown in Table 3.

Figure 11. Elevation analysis of the filters.

We collected surface point cloud data for six water filters before and after backwashing to identify differences between normal and abnormal filter medium surface changes, as shown in Figure 11. Upon comparing the elevation differences of the surfaces pre- and post-backwash, it was observed that the five normal filters exhibited elevation changes exceeding 2 cm. In contrast, Filter 2, identified as abnormal, showed an elevation change of 5 cm.

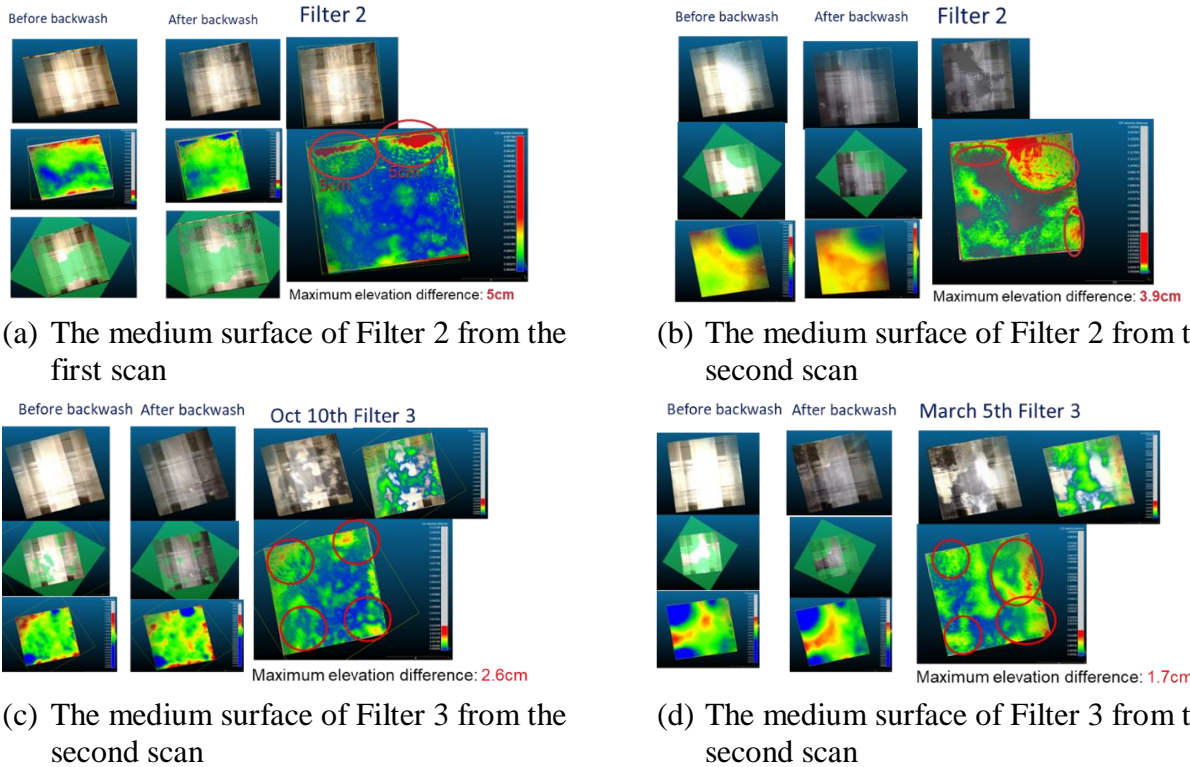
Furthermore, the geometrical characteristics of the medium surface are repetitive. We double-scanned one normal filter (Filter 3) and one abnormal filter (Filter 2), as shown in Figure 12. For Filter 2, both scans of the medium surface show that the medium bumps up on the same edge with maximum elevation differences of 5 cm and 3.9 cm. However, for Filter 3, both scans show that the medium bumps up on four corners with maximum elevation differences of 2.6 cm and 1.7 cm.

Figure 12. Repeatabile geometrical characteristics of the water filter medium surfaces.

Upon double-scanning, we examined both Filter 3 (a normal filter) and Filter 2 (an abnormal filter), as illustrated in Figure 14. The scans of Filter 2 consistently revealed medium bulges on the same edge, with maximum elevation differences of 5 cm and 3.9 cm across the two scans. In contrast, Filter 3 exhibited medium bulges at four corners, with maximum elevation differences of 2.6 cm and 1.7 cm in its two scans. This repetitive pattern in Filter 2 underscores the likelihood of a systematic defect affecting its surface geometry.

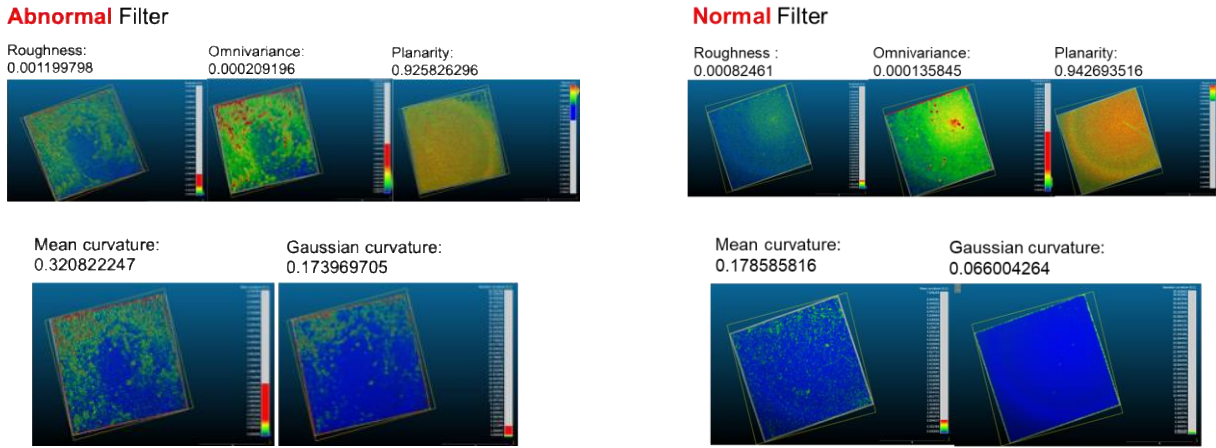
Then, four typical geometrical features (roughness, mean curvature, Gaussian curvature, omnivariance) of the point cloud data were selected to quantitatively represent the differences between the abnormal and normal filters, as shown in Figure 13. Due to uneven medium surfaces, the geometrical features of abnormal Filter 2 (roughness: 0.001199788, omnivariance: 0.000209196, mean curvature:

0.320822247, Gaussian curvature: 0.173969705) are higher than those of normal filters (roughness: 0.00082461, omnivariance: 0.000135845, mean curvature: 0.178585816, Gaussian curvature: 0.066004264). However, the planarity of a normal filter (0.942693516) is higher than that of the abnormal filter (0.925826296).

(a) Geometrical features of abnormal filters

(b) Geometrical features of normal filters

Figure 13. Geometrical features of filter medium surfaces.

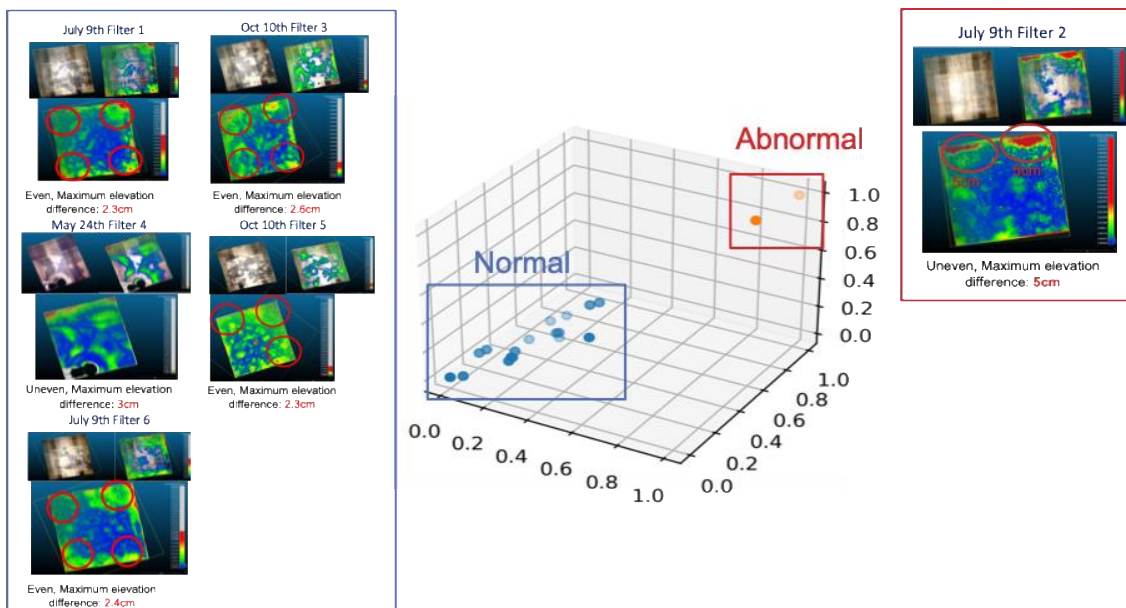
This paper implemented a non-supervised classification technique, specifically K-means, to categorize information elements exhibiting comparable characteristics into unified segments, distinguishing them from elements displaying dissimilar attributes. In the first step, an initial number of clusters was defined. In the second step, each data point was assigned to the closest cluster centroid using the Euclidean distance as the metric, aiming to minimize the within-cluster sum of squares (WCSS). In the next step, the cluster centroids' positions were updated. Steps 1 to 3 were repeated until the cluster centroids did not change. Based on the classification results of the chosen dimensional parameters, the second filtration unit was identified as belonging to the anomalous category, as depicted in Figure 14.

Figure 14. Clustering of geometrical features for abnormal filter detection.

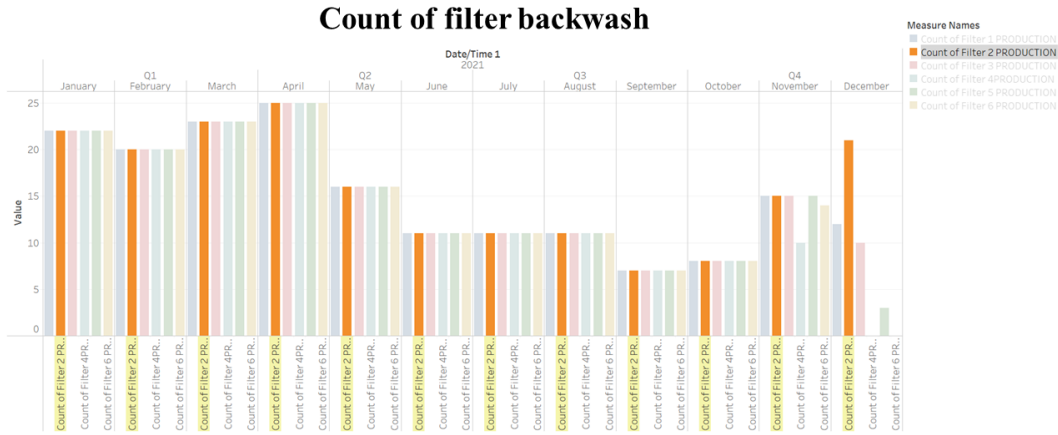
Figure 19. Counts of filter backwash.

We also compared the counts of filter backwash and figured out that Filter 2 had the largest number of backwash as shown in Figure 19. Furthermore, Filter 2 produced less water from January to September 2022 with consistent backwash times, as shown in Figure 20. However, in September, October, and November 2021, Filter 2 had higher production during each backwash, as depicted in Figures 20 and 21. We need to discuss these observations with on-site operators to understand the underlying reasons.

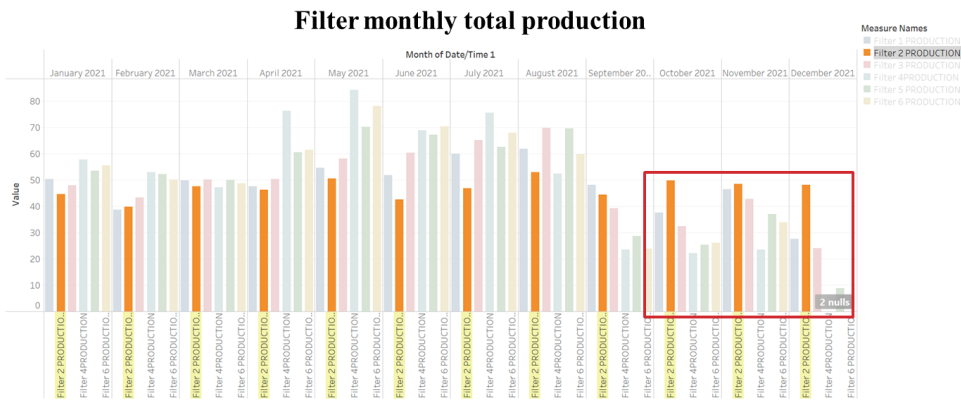
Figure 20. Total monthly filter production.

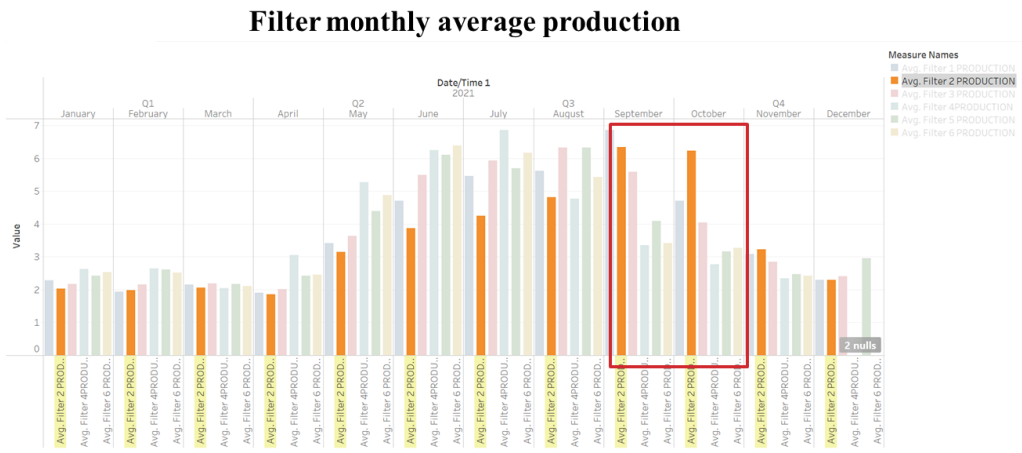
Figure 21. Filter monthly average production.
